Božidar OTAŠEVIĆ, PhD, Assistant Professor
University of Criminal Investigation and Police Studies, Belgrade
Vladimir TONIĆ
Ministry of the Interior, Republic of Serbia, National Centre for
Criminalistic Forensics

Traces of Fire in Cases of Car Self-Ignition¹

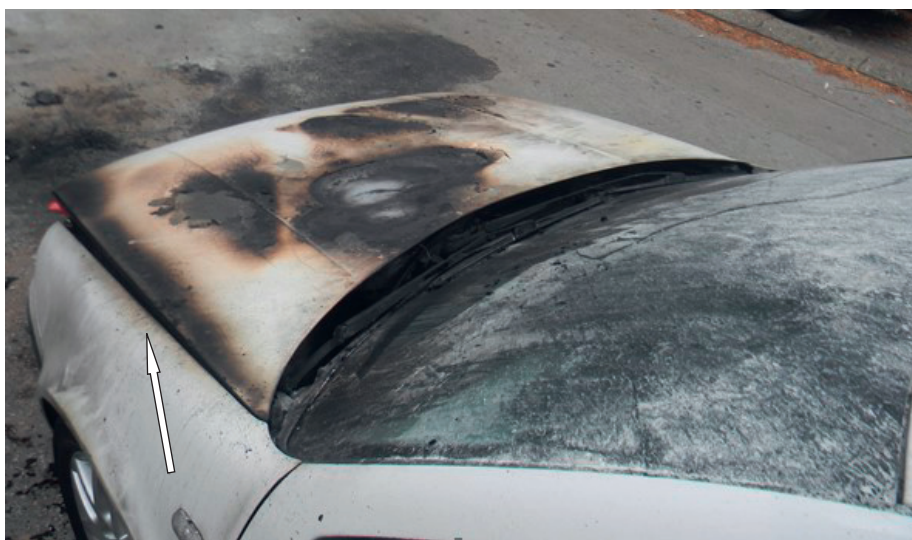
A smoke halo is yet another in the multitude of traces that may be found in the course of fire scene investigation and forensic processing of burned cars (Photograph 4). This trace rules out both the possibility of combustion accelerator presence on the hood and the possibility that the fire started on the outside surface of hood. If the surface of the hood had been splashed with combustion accelerating agent, such as, for instance, petrol, it would drip under the influence of gravity and we would quite certainly have traces of overheating on the front edge, as the lowest point of the hood.

Photograph 4. Smoke halo on the edge of the hood.

In this way we undoubtedly exclude the presence of a burning agent but also the outside surface of the hood as the place where fire originated. Namely, smoke haloes in the form of blackening of hood edges and the area immediately beneath them indicate without any doubt that smoke passed by them along with other products of burning, which stuck to the surface on their way out. As smoke always moves upwards, there can be no doubt that the fire started under the hood.

This trace also shows without a doubt that the hood was in the closed position at the time when the fire broke out. If it had been open, there would be no traces of this kind. The flame in such a case would catch the hood mostly on the inside and would be free to move in space. Had the hood been lifted, there would be no reason for flame and smoke to sneak through.

Sometimes these traces are prominent as in photographs 2 and 4, whereas in some cases they may be barely noticeable, yet they always have the same significance in terms of fire investigation.

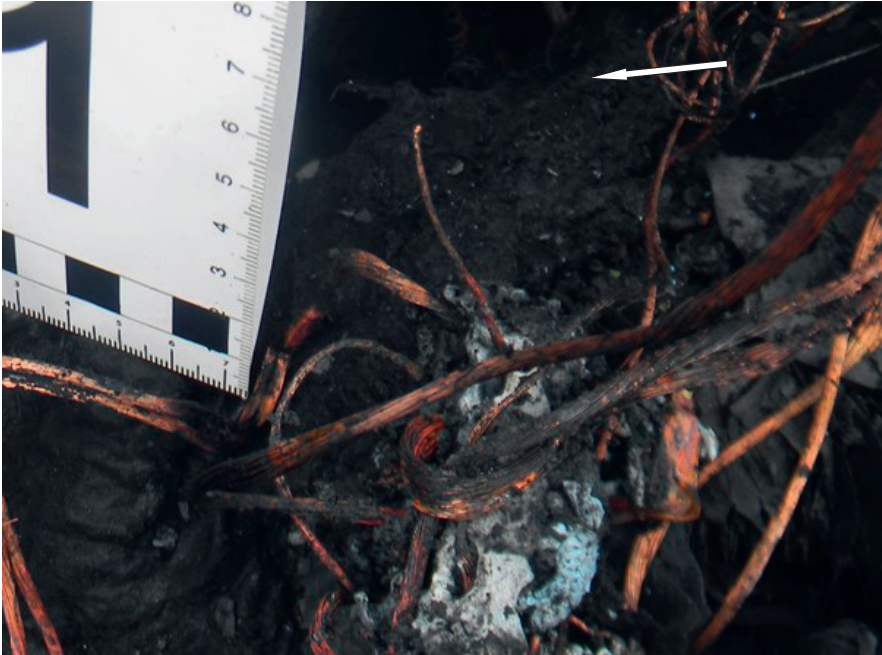
Photograph 5. The trace of a short circuit.

After a detailed inspection of the fire center, we finally establish the cause of fire, that is, the characteristic trace of melted copper conductor in the form of interrupted conductor with rounded edges at the interruption, originating in a well-known way that has already been described (Photograph 5).
